**Flood Control Project Maintenance
Levee Inspections**

Maintenance Issue Types Only, Levee Inspection Report By Mile - Spring 2017

Reclamation District No. 0349 Sutter Island

Waterway	Bank	Unit Miles	Inspection Start/End	Inspector
Unit No. 01 Sacramento River	Right	1.59	04/26/2017 04/26/2017	Herman Phillips

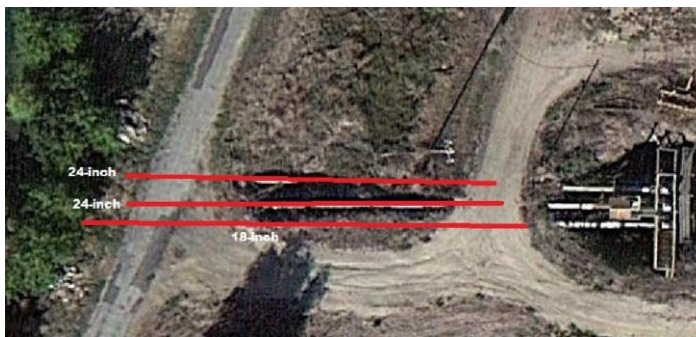
Photo 1 of 2 : UCIP_SP_2017_43446_36725.jpg

Comment Code					
Inspector Comment					
FS_ID:43446 DS_ID:24229 EP_NO: 2954 Repair Type: Non-Urgent Crossing Status: Found UCIP Comments: Dense vegetation limits the inspector's visibility to identify signs of pipe failure (leaks) through the levee slopes. Recommend removing vegetation along pipe alignment to conduct proper inspection of structure and appurtenances. Note date on photos should be 3/18/09 not 7/26/08 camera metadata is incorrect. FIELD_STRUCT_DESC: [R.D. No. 349 Drainage Pumping Plant] 1 of 3: 18-inch pipe through the levee, 7.8 feet below the crown. Siphon breakers on waterward slope. Pumps on platform on landward side. FS Date: 3/19/2009

Aerial map showing alignment of 18-inch pipe.

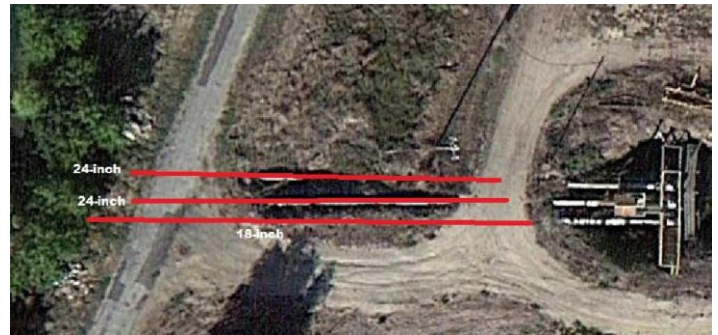
Photo 1 of 3 : UCIP_SP_2017_43445_36730.jpg

Comment Code					
Inspector Comment					
FS_ID:43445 DS_ID:24228 EP_NO: 2954 Repair Type: Non-Urgent Crossing Status: Found UCIP Comments: Dense vegetation limits the inspector's visibility to identify signs of pipe failure (leaks) along the slope. Recommend removing vegetation along pipe alignment to conduct proper inspection of structure and appurtenances. Note date on photos should be 3/18/09 not 7/26/08 camera metadata is incorrect. FIELD_STRUCT_DESC: [R.D. No. 349 Drainage Pumping Plant] 2 of 3: 24-inch pipe through the levee, 7.8 feet below the crown. Siphon breakers on waterward slope. Pumps on platform on landward side. FS Date: 3/19/2009

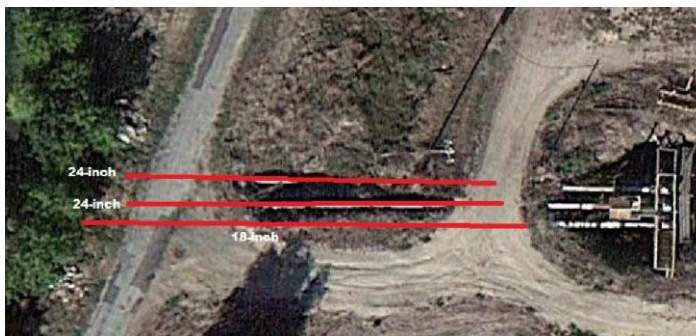
Photo 1 of 3 : UCIP_SP_2017_21632_36733.jpg

FS_ID:21632
DS_ID:24171
EP_NO: 2954
Repair Type: Non-Urgent
Crossing Status: Found
UCIP Comments: Dense vegetation limits the inspector's visibility to identify signs of pipe failure (leaks) along the slope. Recommend removing vegetation along pipe alignment to conduct proper inspection of structure and appurtenances. Note date on photos should be 3/18/09 not 7/26/08 camera metadata is incorrect.
FIELD_STRUCT_DESC: [R.D. No. 349 Drainage Pumping Plant] 3 of 3: 24-inch pipe through the levee, 7.8 feet below the crown. Metal cutoff wall around pipe at landward shoulder. Siphon breakers on waterward slope. Two anchor posts driven into levee on each side of pipe. Pumps on platform on landward side. (Permit No. 2954-1959)
FS Date: 3/19/2009

Aerial view of all 3 pipes through levee.

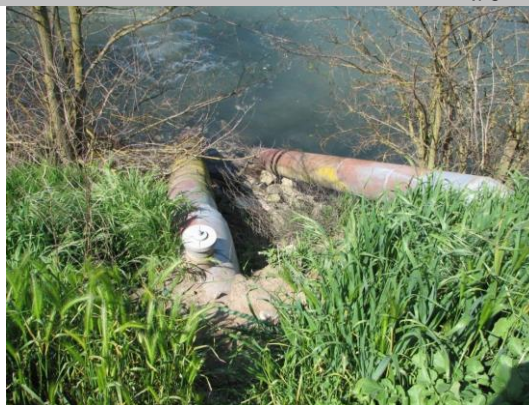
Photo 2 of 3 : UCIP_SP_2017_21632_36731.jpg

View of waterward side--2-24 inch pipes.
